Safety Notice Technical Bulletin No. 019

No. 019	Target audience Affected users	Date 2020-04-09	Number of pages 5
Affected products Battery corpuls cpr P/N 09120	Serial numbers / Lot identification No relation	Software / Firmware Each firmware version up to and including 1.3-004

with this letter we would like to inform you about the safety measure concerning the battery of the corpuls cpr firmware versions up to and including 1.3-004 that have been installed to a limited number of batteries.

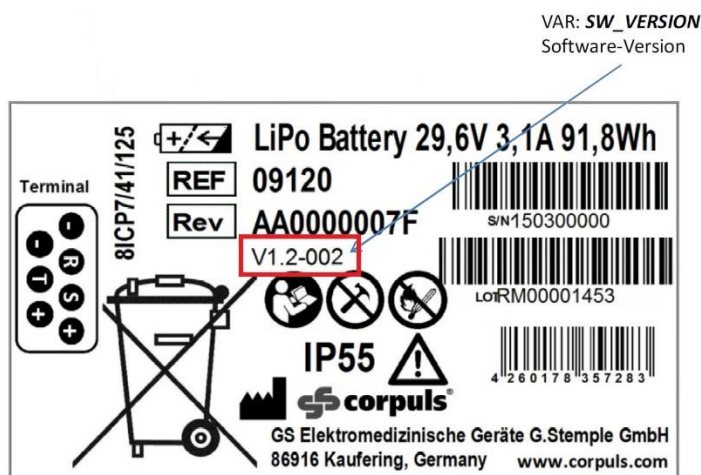
Illustration 1: Rating plate battery corpuls cpr - e.g. firmware version 1.2-002

Your battery corpuls cpr has installed one of the firmware versions up to and including 1.3-004 that we have identified as problematic.

This can be seen on the rating plate of the battery corpuls cpr.

A permanent correction of the malfunction is only possible by updating the affected firmware version up to and including 1.3-004.

Maintenance for each battery will be promptly arranged. A new firmware version 1.4-000 or higher will be installed on your battery corpuls cpr by our authorised sales and service partners. So you will soon have a fully operational corpuls cpr.
