# Turkey Building Damage Assessment

## Overview

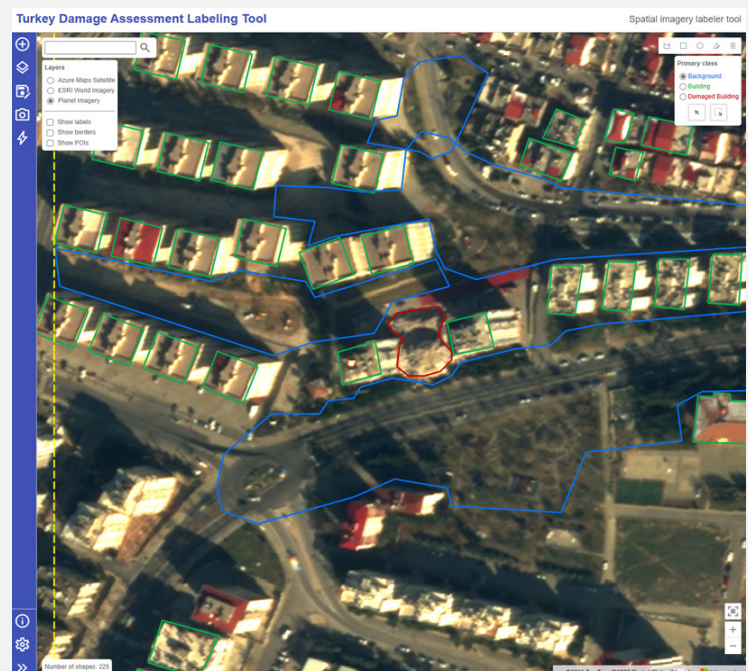
**Figure 1:** Screenshot of the Satellite Imagery Labeling Tool deployment for the city of Marash.

We use satellite imagery from two commercial providers, Planet Labs and Maxar Technologies, which offer images at spatial resolutions of 50cm and 30cm, respectively. We model the problem of identifying damaged buildings from satellite imagery as a semantic segmentation problem. More specifically, we use convolutional neural networks (CNNs) to estimate whether each pixel in an input satellite image is either: part of a damaged building, part of an undamaged building, or part of the background (i.e., anything not belonging to the first two classes). We pre-train a CNN on the xBD dataset [1] which provides fine-grained building damage polygons across different types of disasters. We then fine-tune a CNN for each area of interest (AOI) with labels collected using our open-source "satellite-imagery-labeling-tool" [2]. This tool allows a user to quickly annotate satellite imagery with examples of the three classes (see Figure 1 for an example of this interface) and integrate their annotations into a machine learning model training workflow.

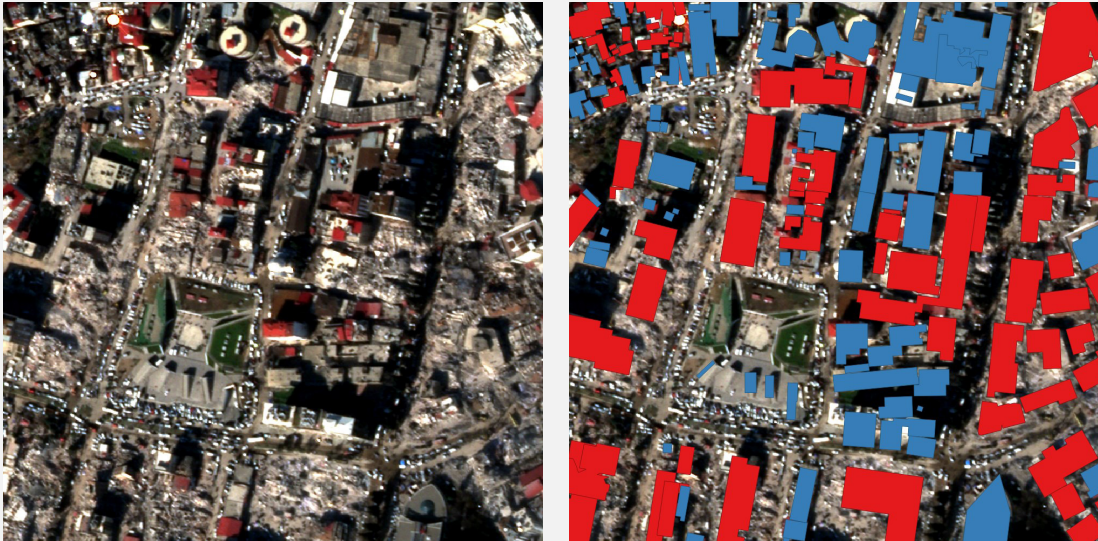
We found 3,005 damaged buildings in Marash, representing 7.44% of the total number of buildings in the city. The damage to these buildings has impacted a significant portion of the population, with 148,388 people, or 24.33% of the total population of 610,000, being affected by the disaster. The most significantly damaged area of the city is around the Culture Park in the city center, seen in Figure 4.

**Figure 4:** Extensive damage around the Culture Park area of Marash. Planet Labs PBC, February 9th.

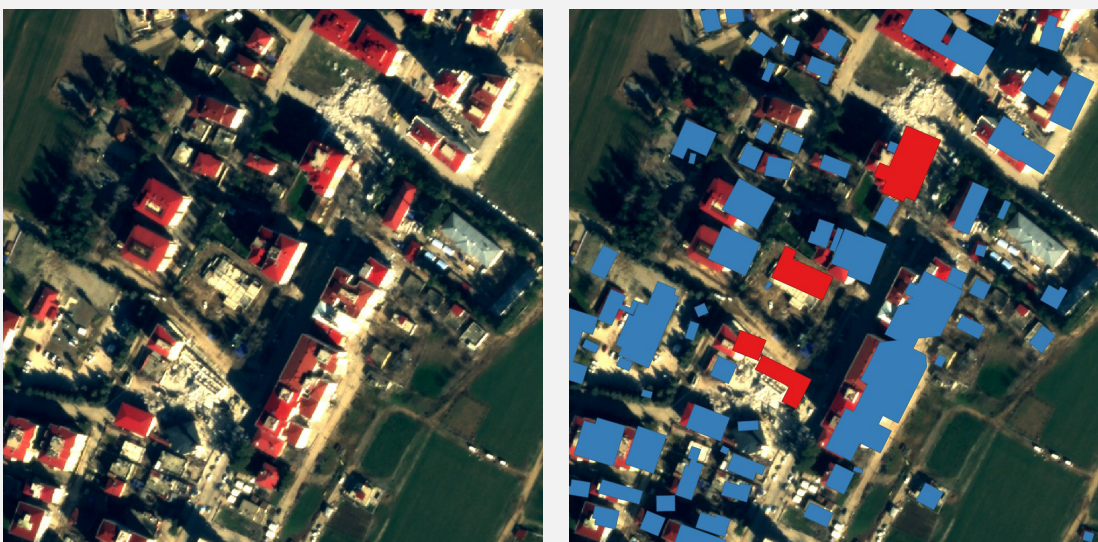
We found that damage in the city of Turkoglu was distributed throughout the city with fewer large clusters of damage (as compared to the other AOIs). In total, 4.85% of the buildings in the city were damaged, affecting an estimated 6,202 people. Figure 5 shows an example of two destroyed buildings along one of the major streets through the city.

**Figure 5:** Several destroyed apartment buildings in Turkoglu. Planet Labs PBC, Feb 9th.

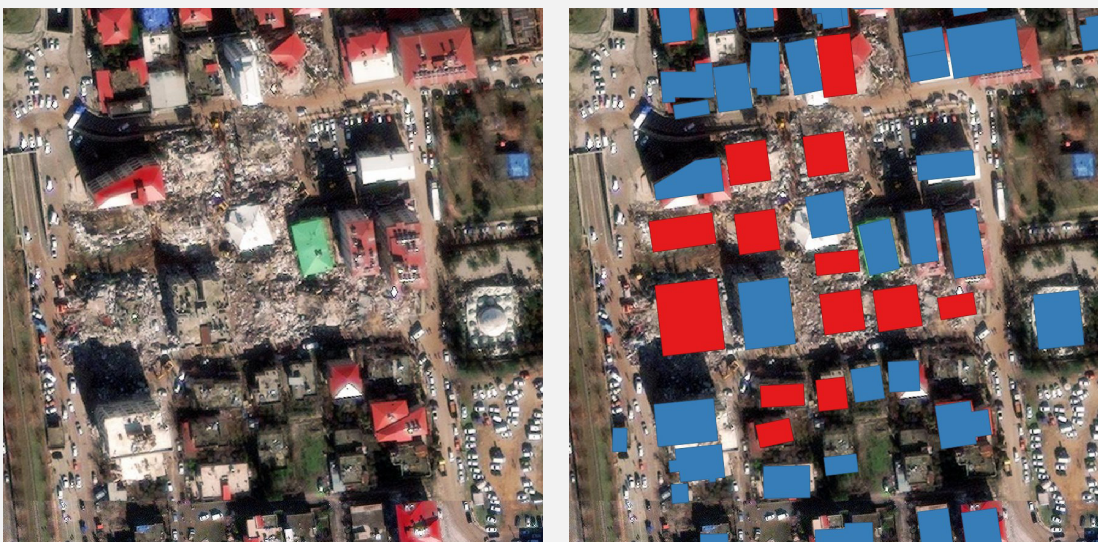
We found 13,215 damaged buildings in Islahiye, representing 2.48% of the total number of buildings. By the percentage of damaged buildings Islahiye was the least affected out of the four study areas, however we observed that the damaged buildings were clustered in more densely populated areas. For example, Figure 7 shows a group of nine apartment buildings that were all destroyed. Even though similar numbers of buildings were destroyed between Islahiye and Nurdagi, we estimate over one thousand more people were affected in Islahiye.

**Figure 7:** A set of nine destroyed 5-story apartment buildings in downtown Islahiye. Maxar Technologies, Feb 7th.

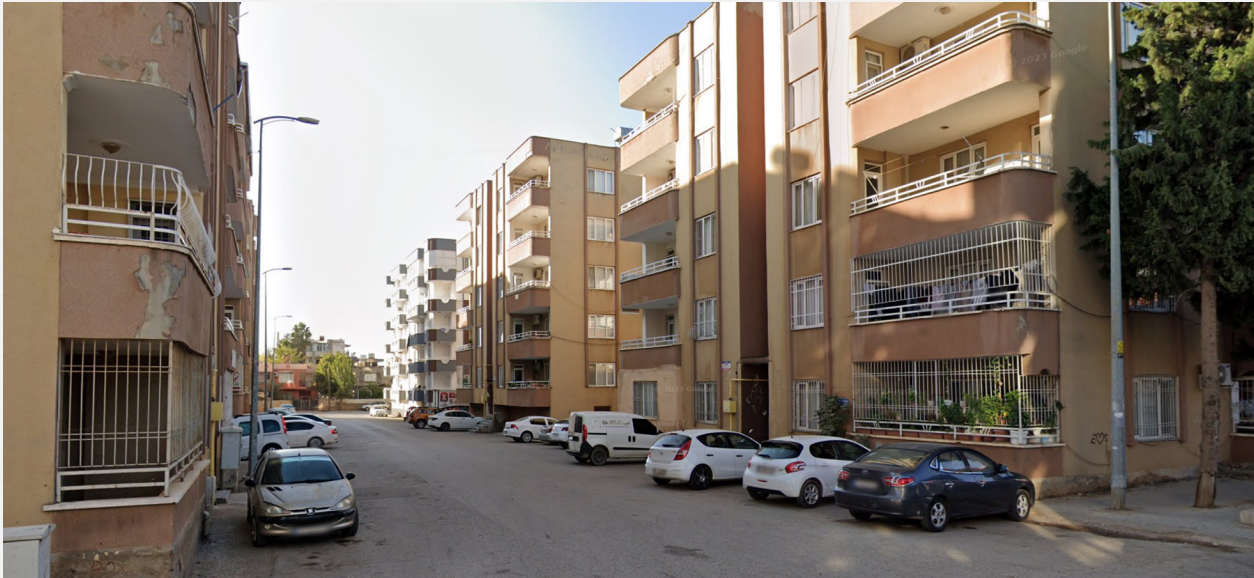
**Figure 8.** Pre-disaster Google Street View imagery from Islahiye of the destroyed apartments shown in Figure 7.
