# COLD WALL EQUIPMENT HAZARDS

ALLIANZ RISK CONSULTING

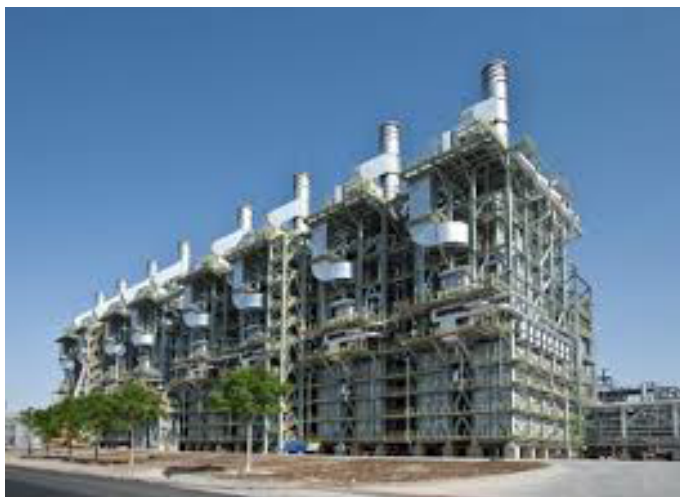
A good way to detect hot spots before they become an issue is with an effective thermography inspection program e.g. an on-line thermal IR scan or a scheduled inspection. In cases where this is not possible, temperature sensitive paints are a viable alternative as an effective warning system of localized overheating.
